BLM Cedar City Field Office Site Inspection Report

Dec.1, 2009

File: UTU-80852; Blawn Mountain Kaolin Mine Project
Sandy Nell / Lone Star Mining

Inspector: Ed Ginouves, CCFO Mining Engineer

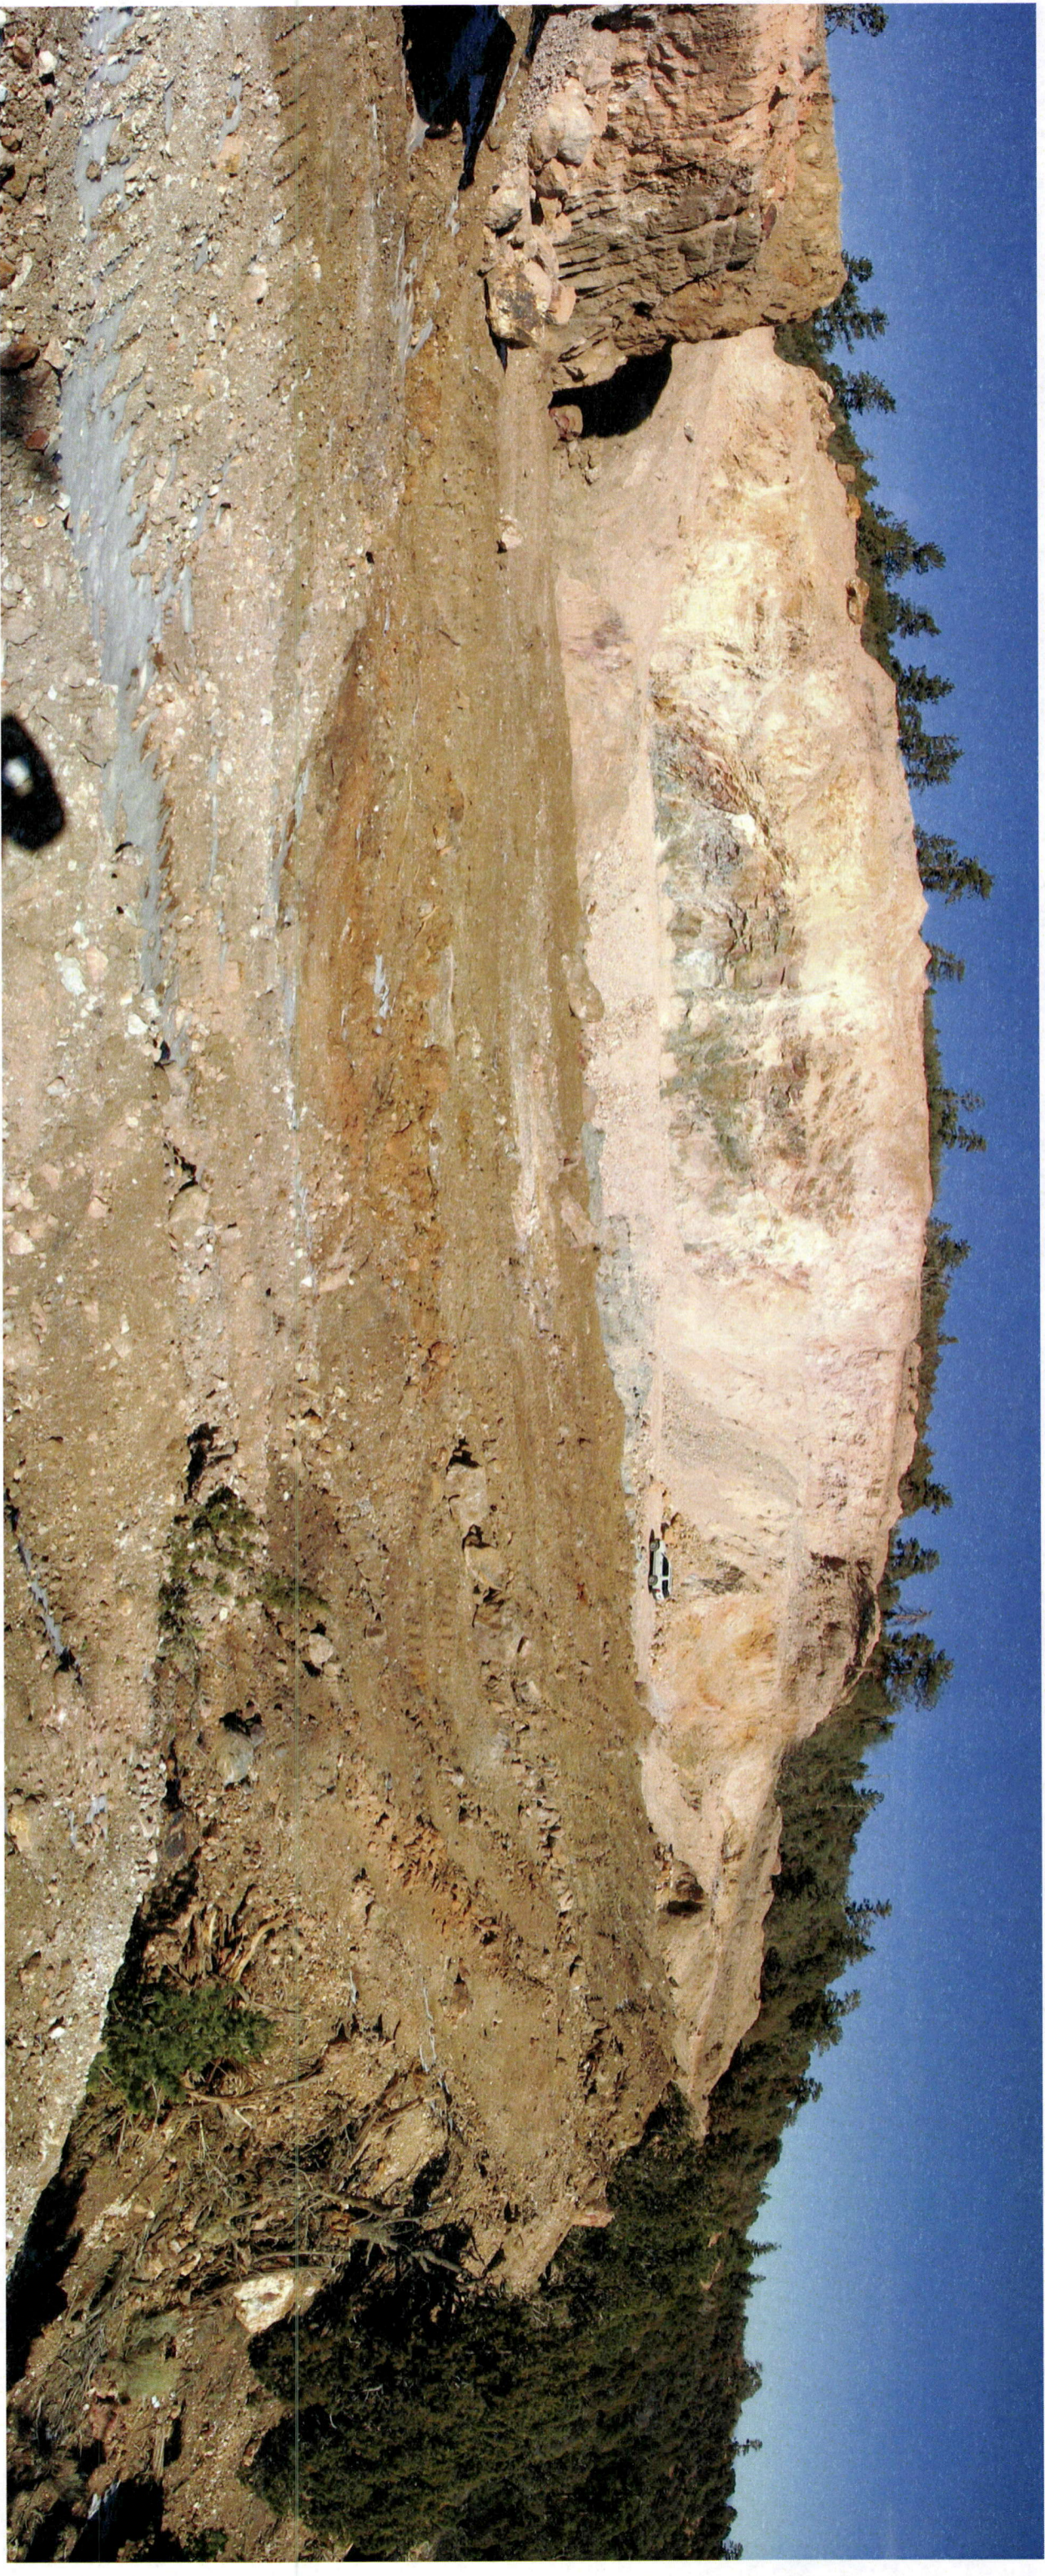
UTU-80852: Blawn Mtn. Kaolin
December 1, 2009

Panoramic view of mine site looking north from the southern edge of the disturbance. Foreground is bulldozer reclaimed south portion of the mine site. The pinkish band to the left of the vehicle is a zone of alunitic clay that is unminable due to excessive alkali metal content. The same zone lies ten feet behind the dark grey face to the left of the trackhoe. This face would be benched to create a reclaimable slope.

Some additional clay removals had occurred from the northeast corner of the mine-site, adjacent to where the access road enters the site. The gross disturbed footprint had not increased except for some material pushed or raveled down-slope at the perimeters of the mine site reclaimed areas. The principal remaining reclamation at the mine site will be the reduction of the western highwall.

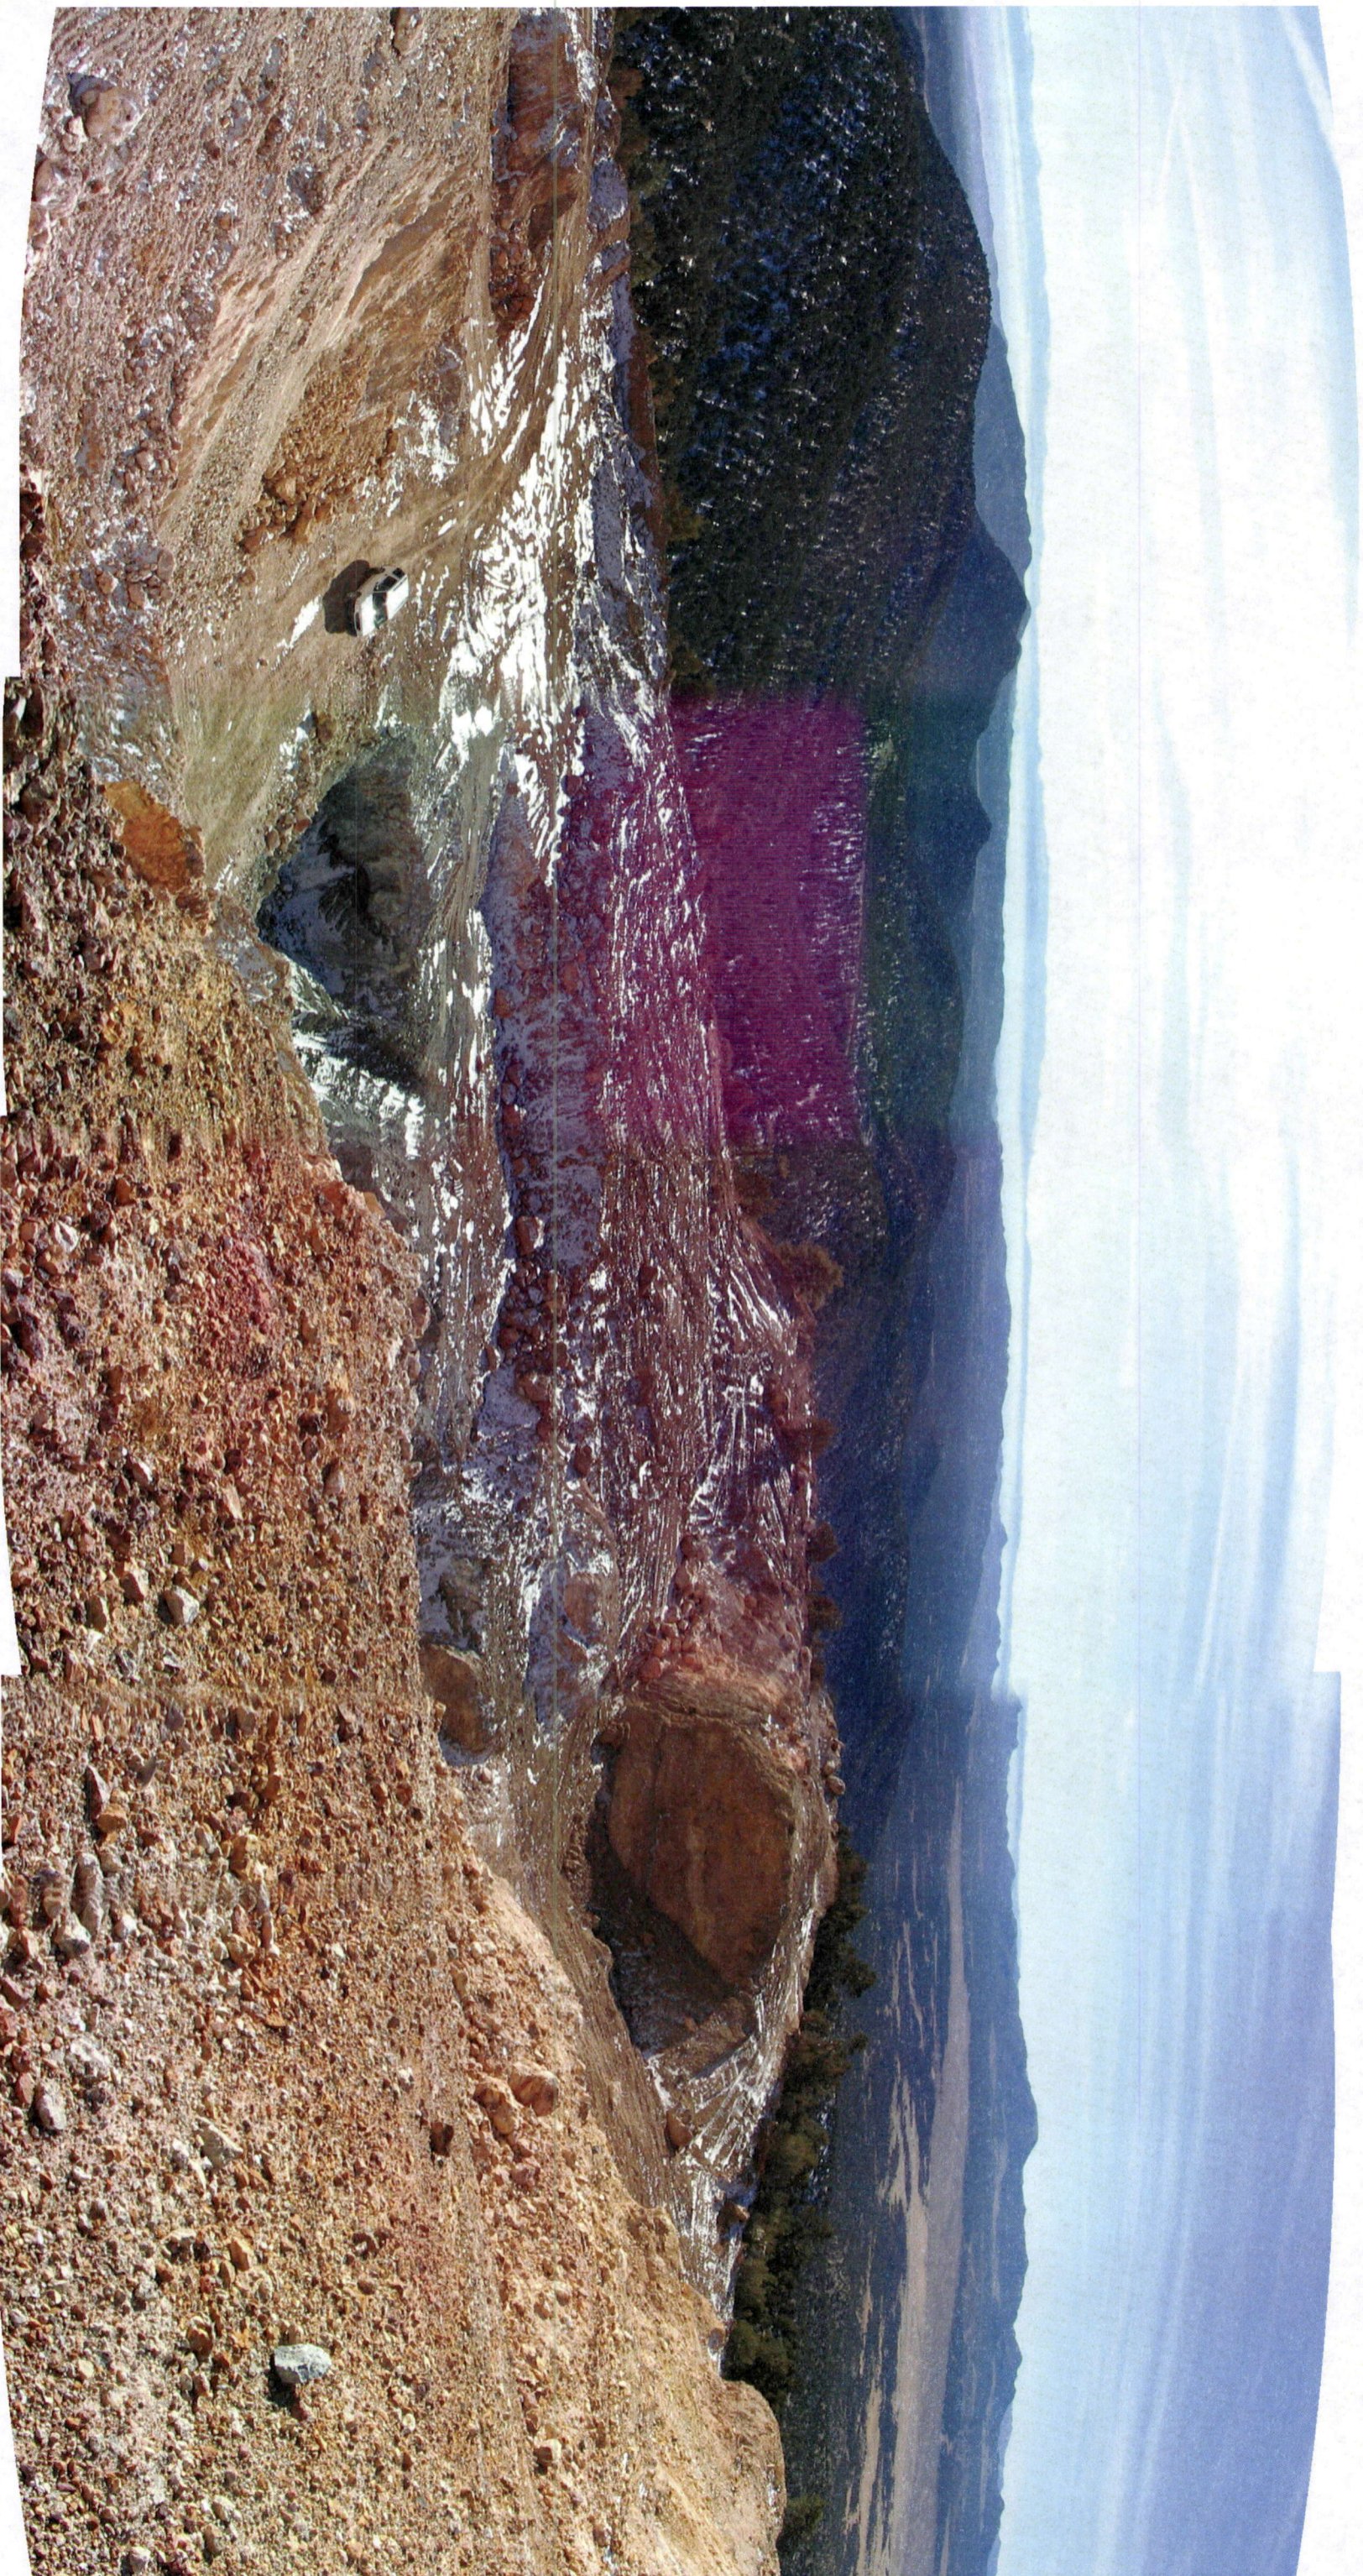
UTU-80852: Blawn Mtn. Kaolin
December 1, 2009

Panoramic view of mine site looking south from the northern edge of the disturbance.

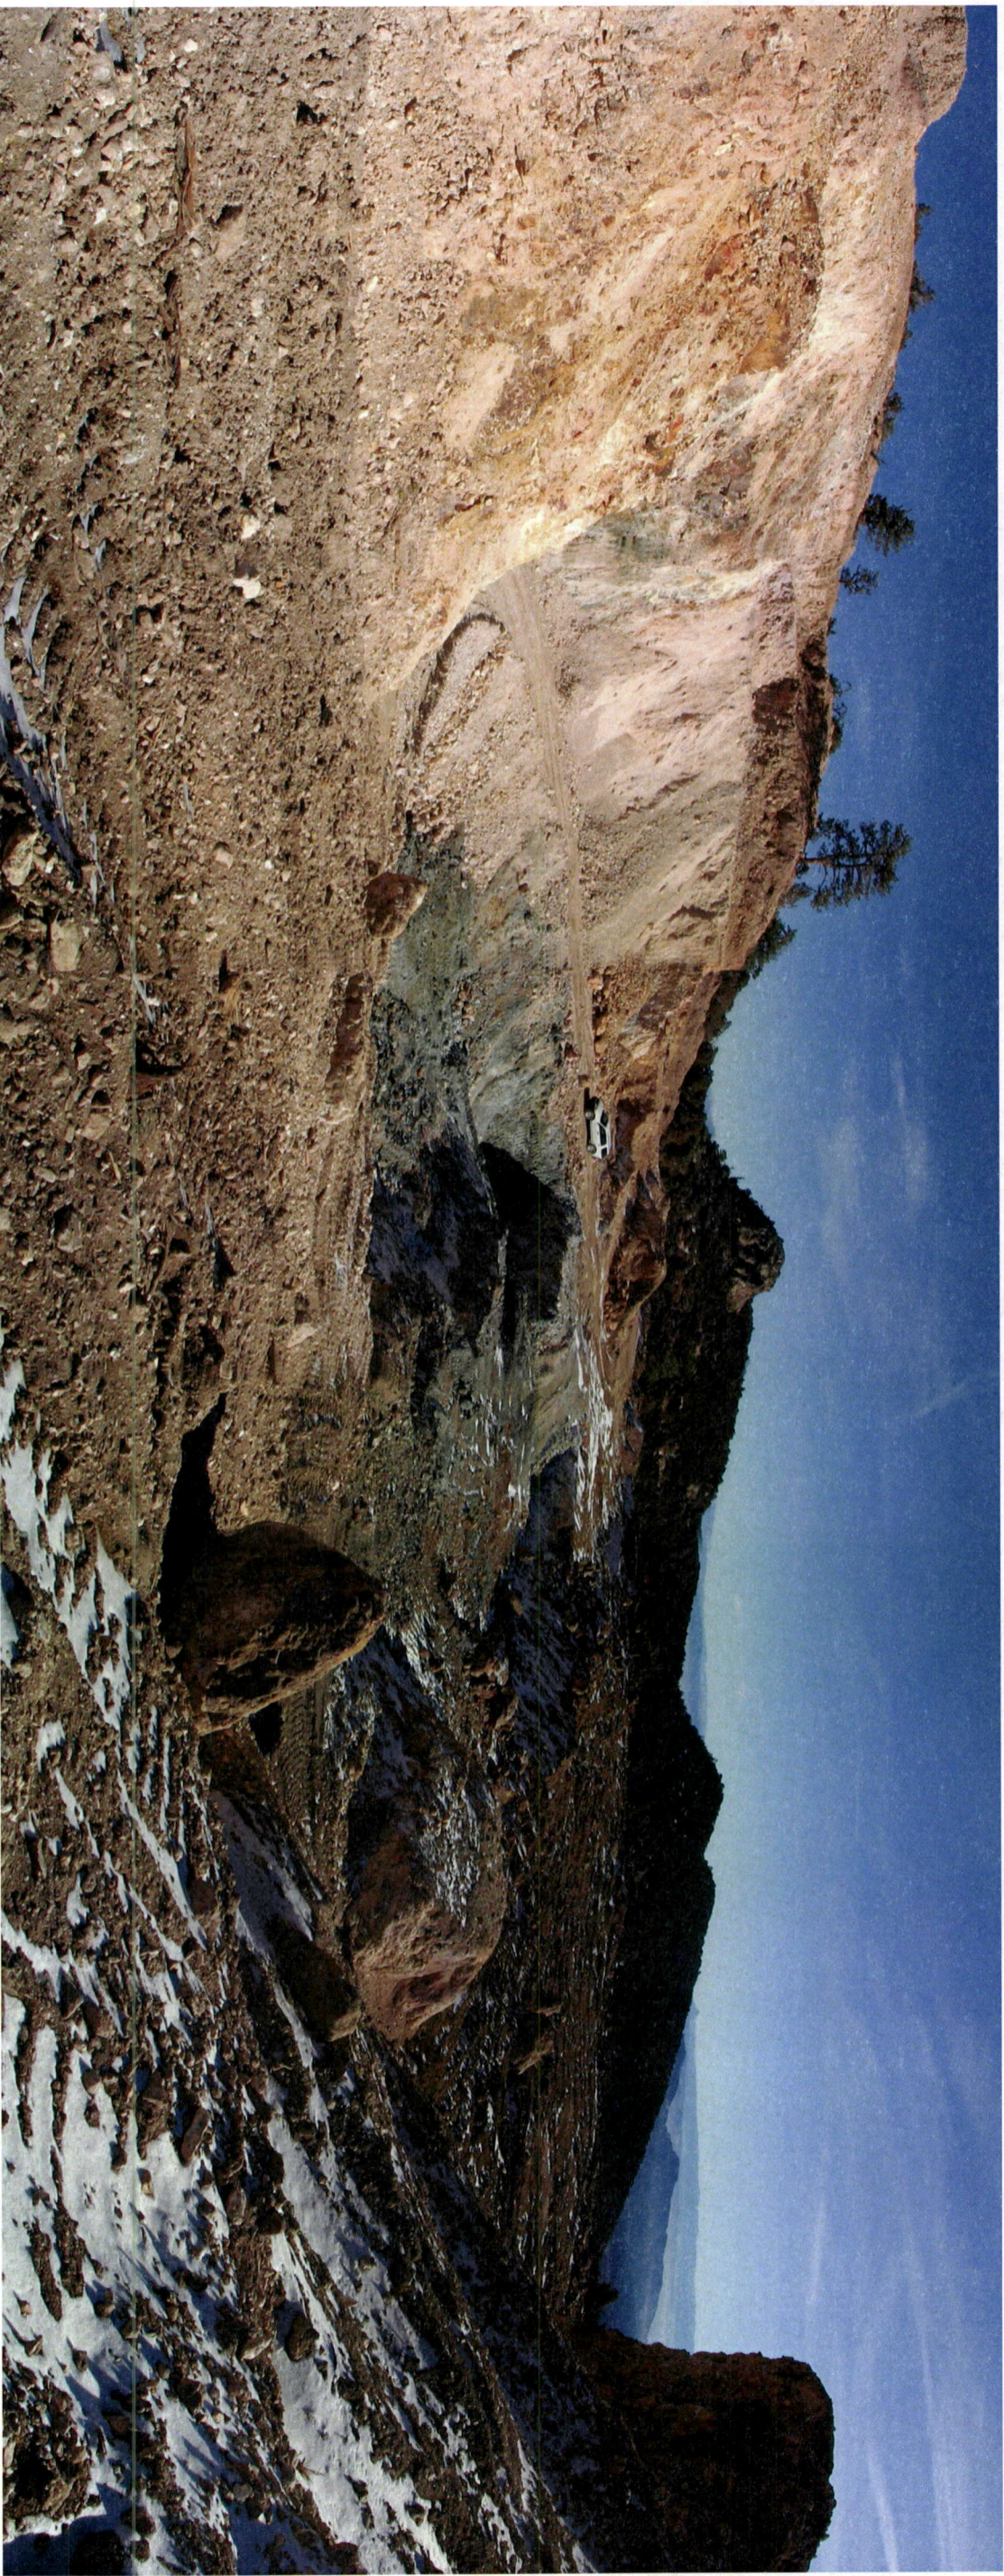
UTU-80852: Blawn Mtn. Kaolin
December 1, 2009

Panoramic view of mine site looking easterly from the southwest edge of the disturbance.

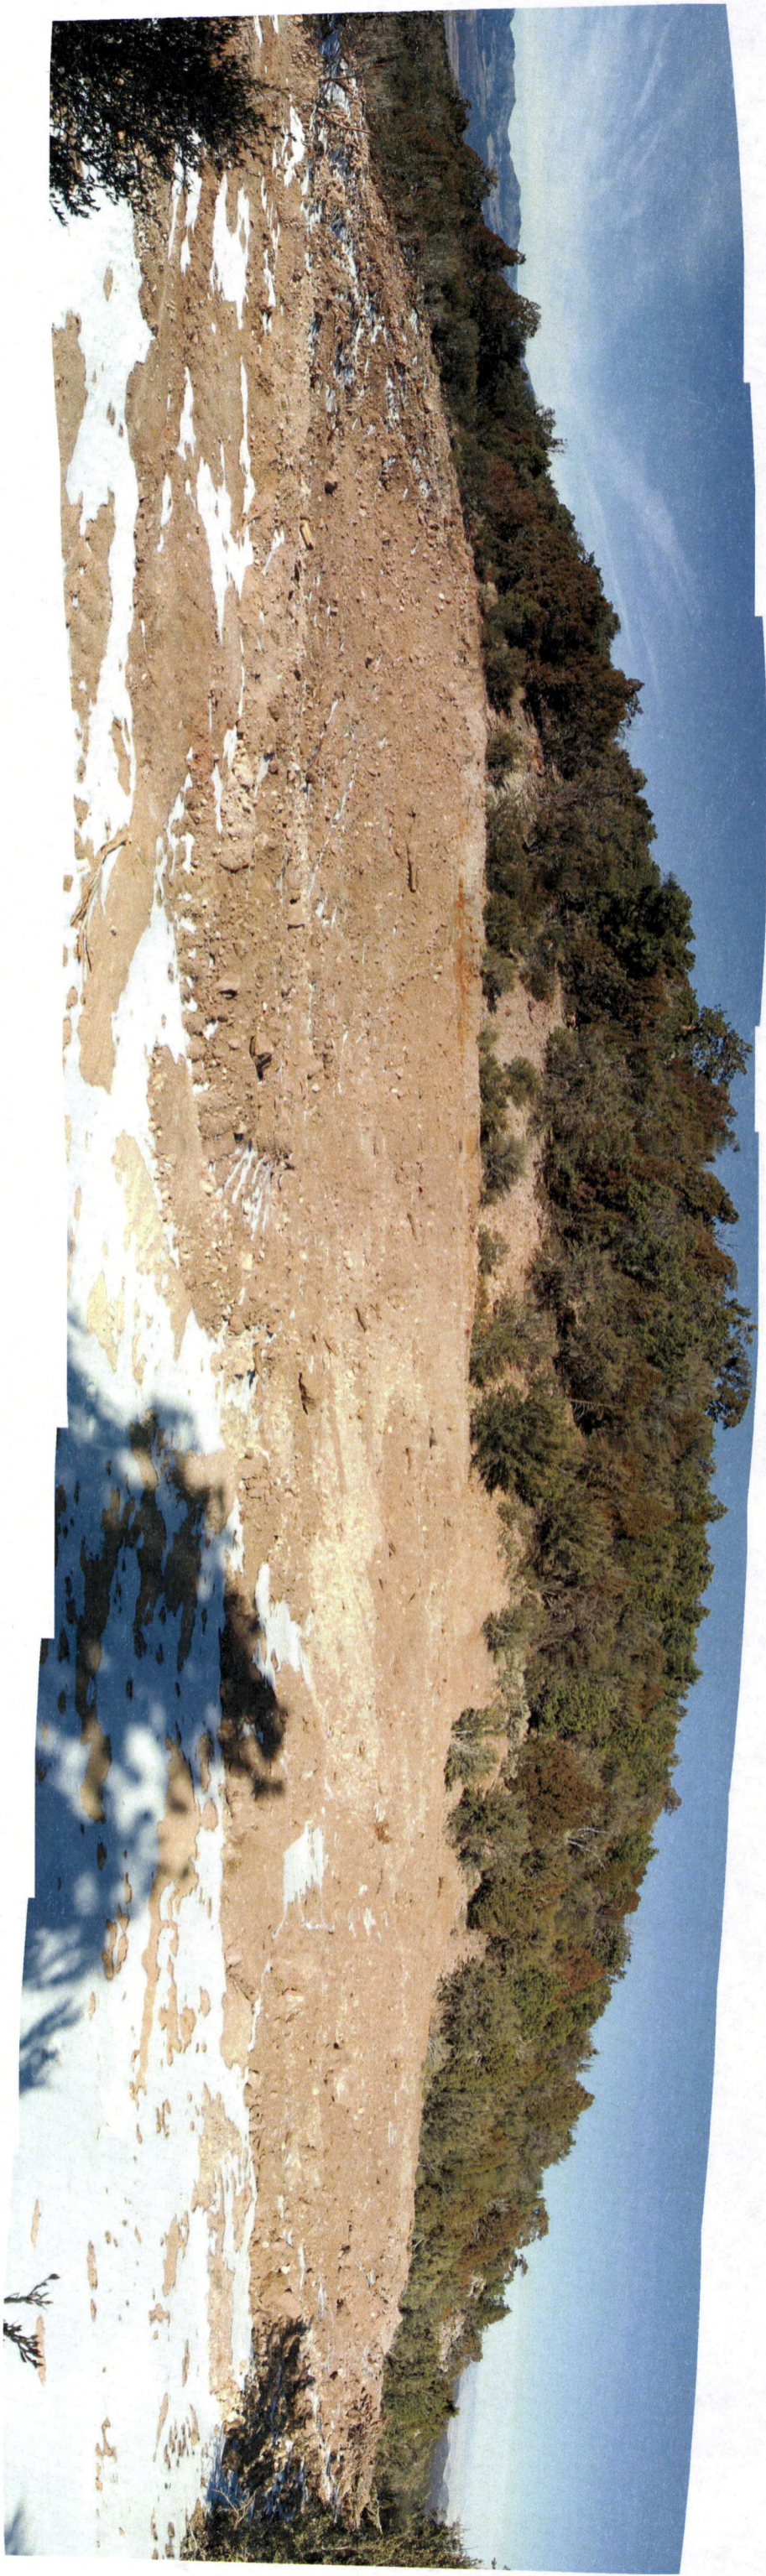
UTU-80852: Blawn Mtn. Kaolin
December 1, 2009

View of earthwork reclaimed ~1/2 acre unauthorized bulk sampling effort 1/4 mile to the northwest of the mine site on the summit of Blawn Mtn.

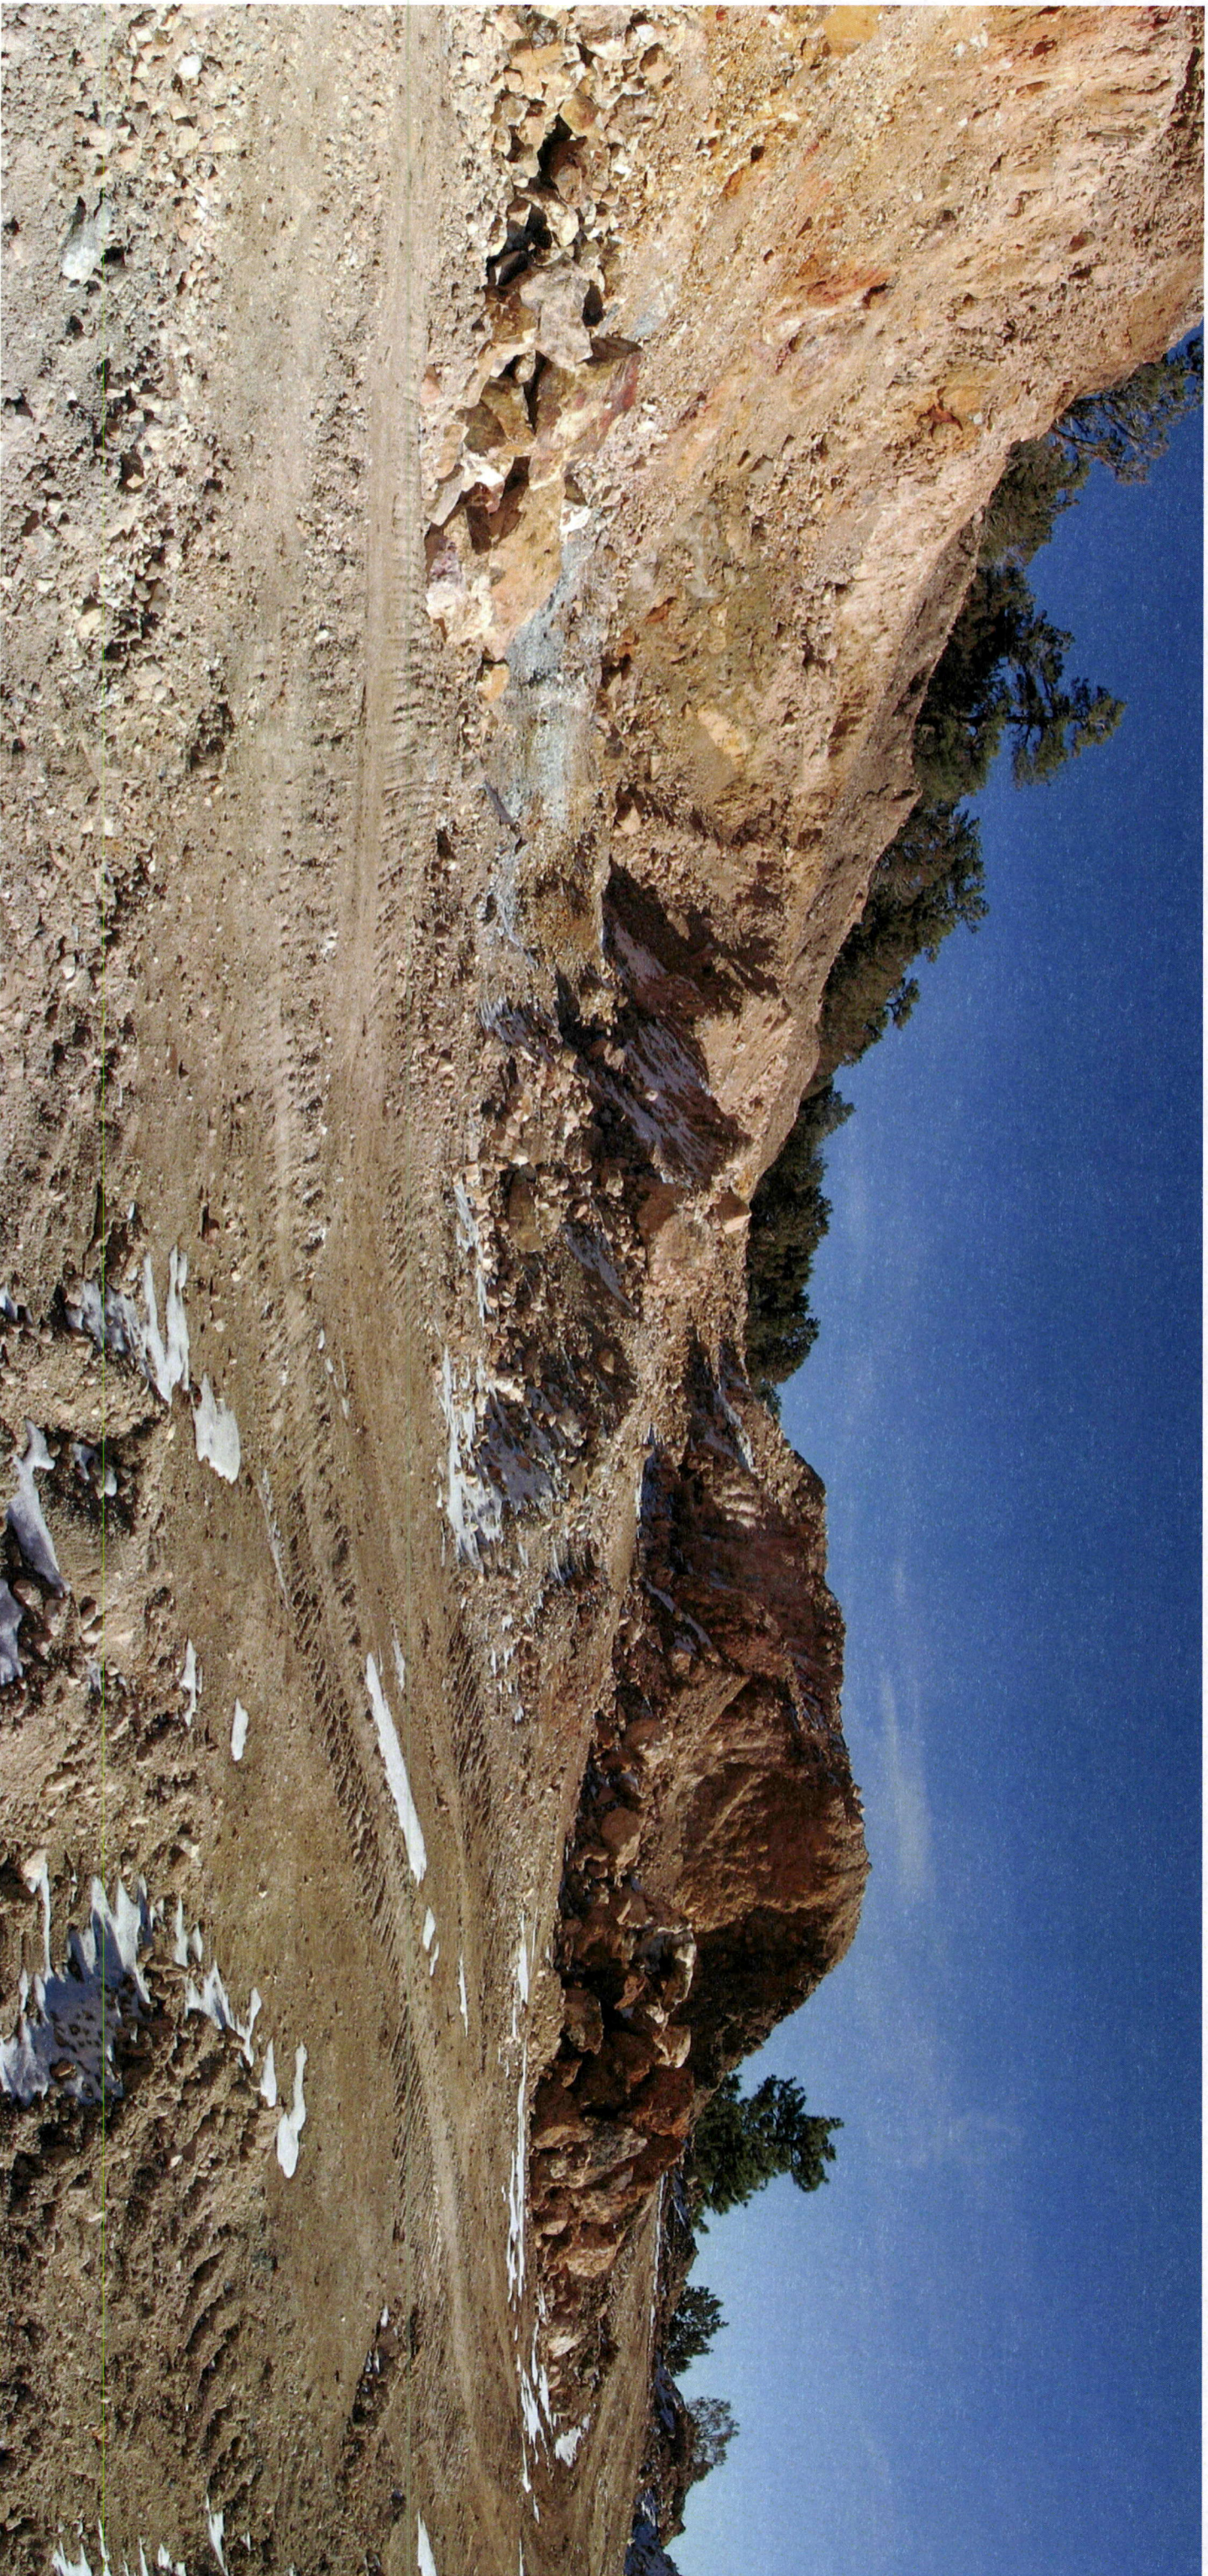
UTU-80852: Blawn Mtn. Kaolin
December 1, 2009

Panoramic view of active mine area on northeast corner of the site.
